Building Inspection Report

7571 S. Anywhere St. Littleton, CO

7/7/2007

Murphy Home Inspection Services, Inc.
1527 Mountain Maple Ave.
Highlands Ranch, CO 80129

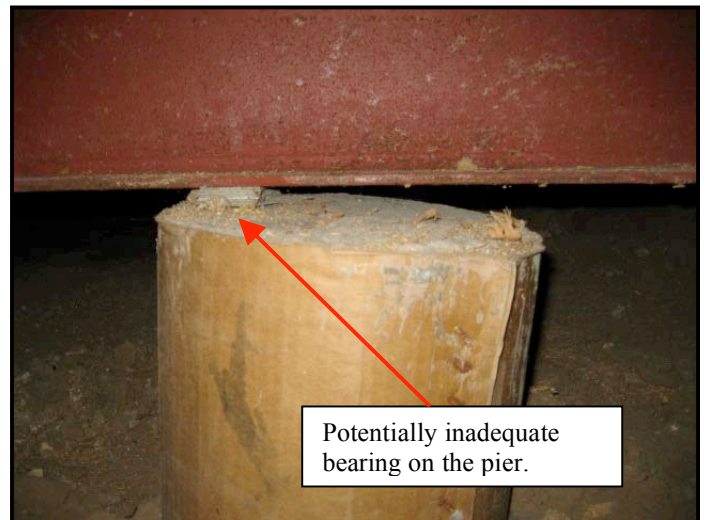
- **Repair:** The central beam is not properly supported at one or more of the concrete support columns. Columns are typically designed to be concentrically loaded. The column and beam connection closest to the access hatch is not concentrically loaded. We suggest a review by a qualified expert, typically a Professional Engineer specializing in forensics, and the condition be modified as necessary.
- **Monitor:** At the time of the inspection the sub-basement crawlspace was observed to be dry. All construction debris and/or trash should be removed from the crawl space ASAP. Organic debris in the crawlspace and around the property increases risk of insect or rot damage. Organic materials can be a food source for mold. See they comment below in the limitations section.

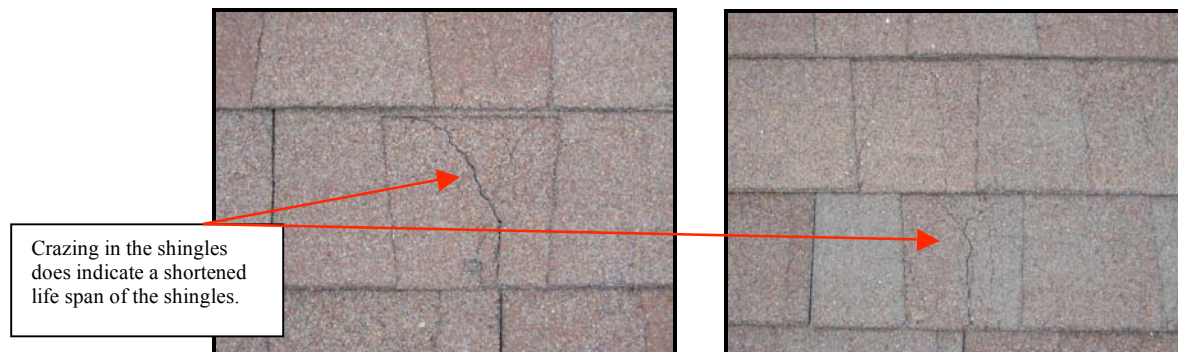
- **Major Concern:** Crazeing or small cracks were observed in the roof surface. See the photographs below. Crazeing of the roof surface can be attributed to several factors. Whatever the specific reason for this crazeing is, it does indicate a shortened service life of the product. Further review by a qualified roofing expert is suggested. Minimally we suggest that you request a five roof certification from the seller. In the long term you should budget for eventual roof replacement.

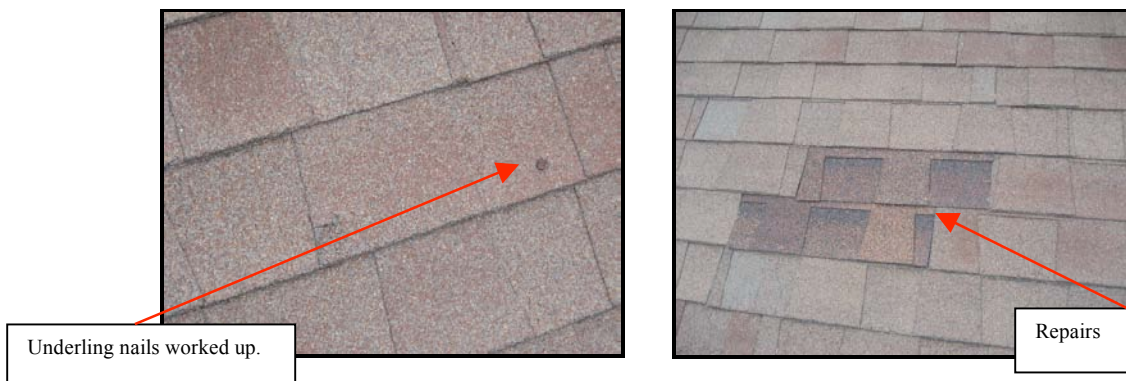
- **Repair: Monitor:** Nails from the underlying layers of shingles and or flashings are working their way up through the top layer of shingles in isolated areas. See the photograph below on the left. Ideally the affected shingles should be repaired/replaced. As the exposed fasteners are minimal at this time it may be possible to simply seal the exposed nail heads with a high quality mastic. It will be necessary to periodically check these repairs and reseal them. For additional information we suggest that you consult with a roofing expert.

- **Monitor:** Prior repairs to the roofing are evident. See the photograph above on the right. This would suggest that problems have been experienced in the past. This area should be monitored.

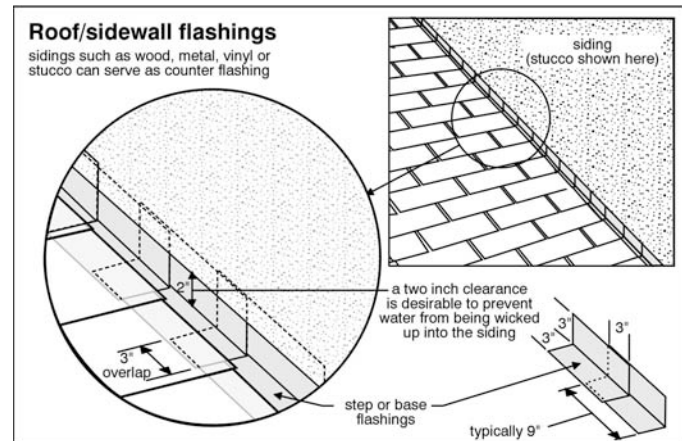
- **Repair:** The clearance of the siding to the roof coverings is insufficient. This condition leaves the siding vulnerable to rot. This detail is usually repaired when siding needs repair or replacement or when re-roofing work is performed. The illustration to the right indicates stucco wall cladding. Manufactures of hardboard or cement fiber siding also require a minimum of 1"-2" of clearance for their products as well. Note the diagram to the right.

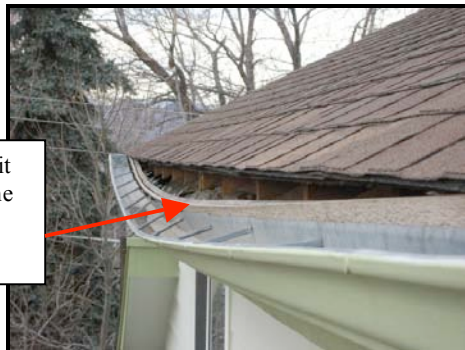
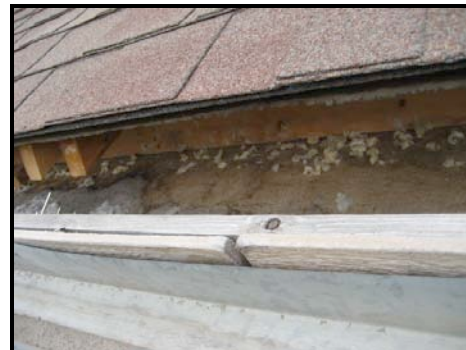
- **Major Concern: Repair:** The soffit and fascia at the upper roof at the south side has pulled from the home. This is very likely the result of last year's severe winter and extreme amount of snow. The damage to this area requires immediate repair. See the two photographs below.

Entire fascia and soffit has pulled loose on the south side of the building

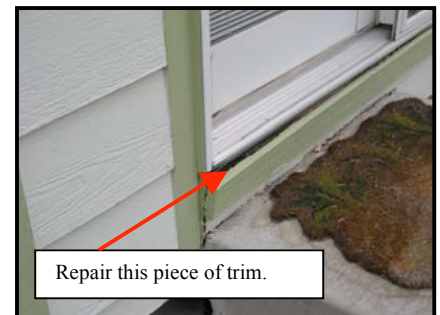
- **Repair:** The damaged trim below the rear patio door should be repaired or replaced as necessary. See the photograph to the right.
- **Monitor: Repair:** There is a vertical crack in the veneer brickwork at the masonry between the two garage doors. The exact cause of the cracking is not determinable based on this limited visual inspection. A possible cause is freeze thaw cycles. This does not appear to be a structural concern and repair other than for aesthetic is optional.

Repair this piece of trim.

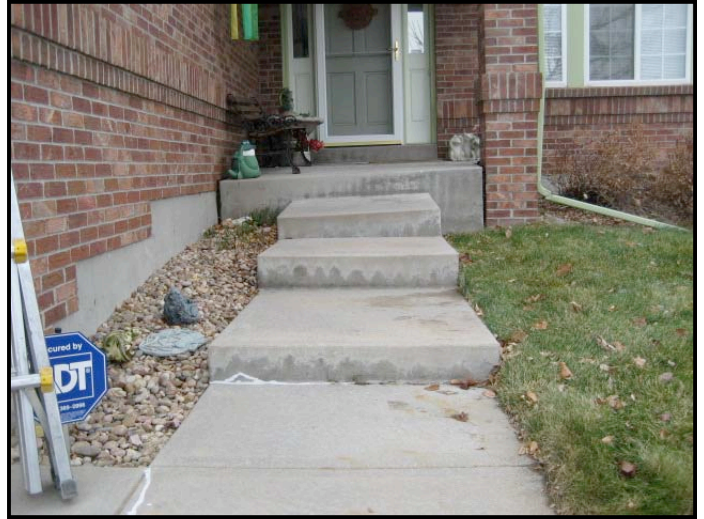
- **Possible Major Concern, Monitor:** The front porch and walk way has settled relative to the house proper. This is a common condition normally attributed to inadequate compaction during original construction. At the time of the inspection a modest trip hazard exist. Ideally the front walk and stoop should be removed and repoured if only for aesthetic reasons. Mudjacking of the front walk and stoop could also be considered. Minimally the condition should be monitored and repaired if a significant trip hazard develops.
- **Repair, Safety Issue:** The rear patio is also cracked and has settled and has some potential trip hazards. This condition should also be monitored and repaired if the condition worsens. If the front porch is ever repaired/repoured it would be prudent to replace this patio at the same time.

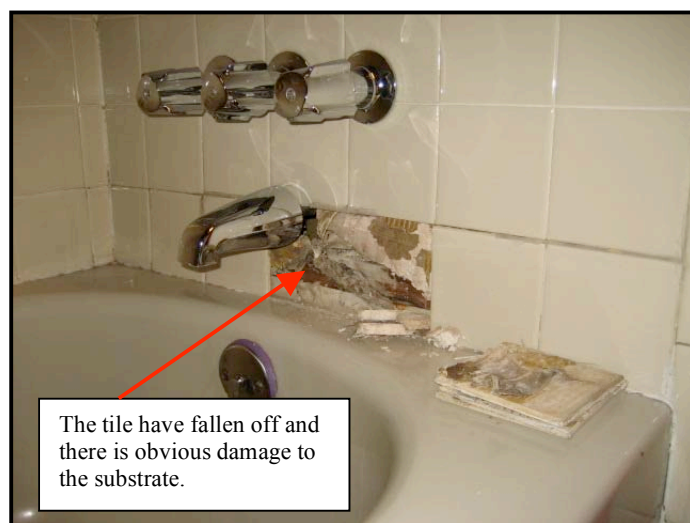
- **Repair:** The tile surround for the second floor hall bathtub is in need of major repair. There are several loose and or missing tiles. See the photograph to the right. The condition of the substrate is damaged based on the limited accessibility and will likely require substantial repairs depending on what conditions exist once the major repairs are in process. We suggest consultation with a contractor to determine the extent and cost of repairs required.
- **Monitor:** The majority of plumbing fixtures are at or approaching the age where they may require some routine maintenance and or repairs or eventual replacement. It would be typical to have to replace older washer or faucet cartridges to keep faucets from dripping.

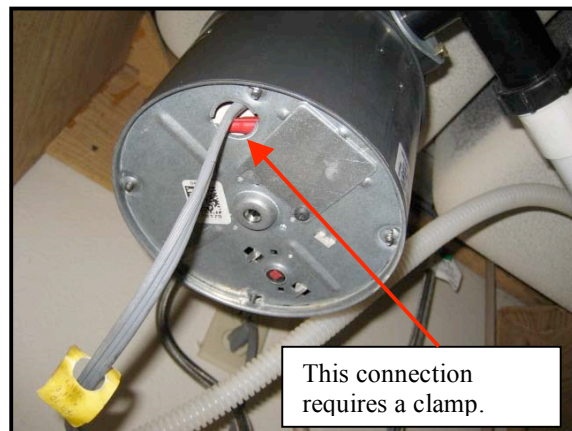
- **Repair: Safety Issue:** The wiring leading to the waste disposer is deficient. The wiring is not properly clamped at the bottom of the disposer exposing the wires to potential abrasion on the housing of the disposer. See the photograph to the right. This is potentially a dangerous condition that could be a shock or potentially an electrocution hazard. The wiring should be repaired as soon as possible.
