Building Inspection Report

7571 S. Anywhere St. Littleton, CO

7/7/2017

Murphy Home Inspection Services, Inc.

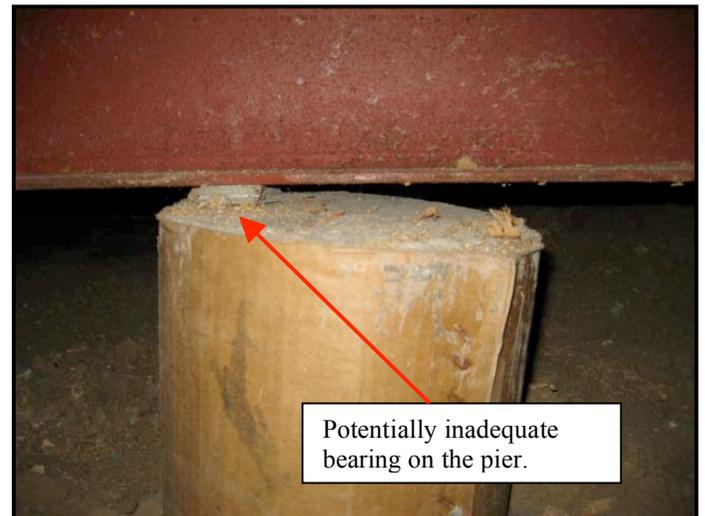
Repair: The central beam is not properly supported at one or more of the concrete support columns. Columns are typically designed to be concentrically loaded. The column and beam connection closest to the access hatch is not concentrically loaded. We suggest a review by a qualified expert, typically a Professional Engineer specializing in forensics, and the condition be modified as necessary. See the photograph below in the structure section of the report.

- **Repair:** The central beam is not properly supported at one or more of the concrete support columns. Columns are typically designed to be concentrically loaded. The column and beam connection closest to the access hatch is not concentrically loaded. We suggest a review by a qualified expert, typically a Professional Engineer specializing in forensics, and the condition be modified as necessary.
- **Monitor:** At the time of the inspection the sub-basement crawlspace was observed to be dry. All construction debris and/or trash should be removed from the crawl space ASAP. Organic debris in the crawlspace and around the property increases risk of insect or rot damage. Organic materials can be a food source for mold. See they comment below in the limitations section.

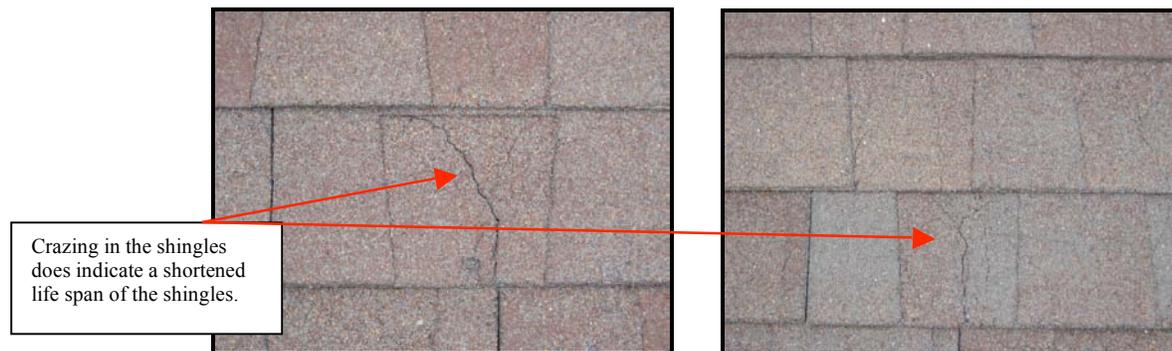
Major Concern: Crazeing or small cracks were observed in the roof surface. See the photographs below. Crazeing of the roof surface can be attributed to several factors. Whatever the specific reason for this crazeing is, it does indicate a shortened service life of the product. Further review by a qualified roofing expert is suggested. Minimally we suggest that you request a five roof certification from the seller. In the long term you should budget for eventual roof replacement. See the photographs below in the roofing section.

- **Major Concern:** Crazeing or small cracks were observed in the roof surface. See the photographs below. Crazeing of the roof surface can be attributed to several factors. Whatever the specific reason for this crazeing is, it does indicate a shortened service life of the product. Further review by a qualified roofing expert is suggested. Minimally we suggest that you request a five roof certification from the seller. In the long term you should budget for eventual roof replacement.

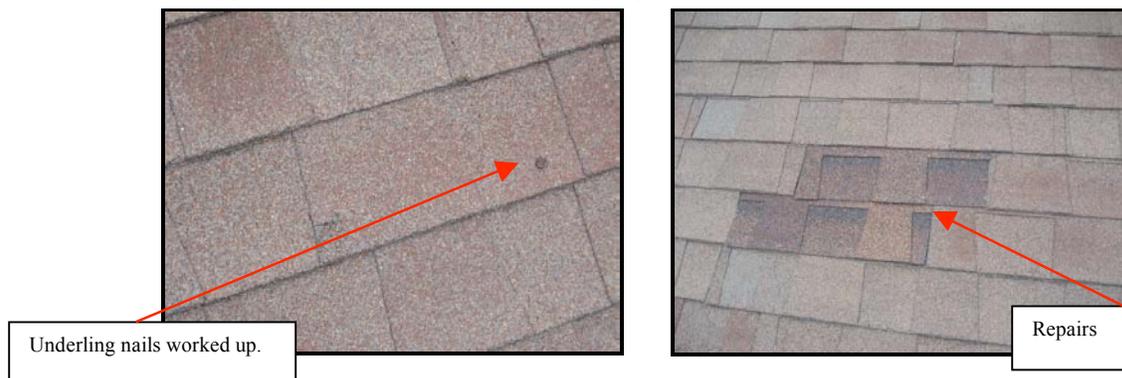
- **Repair: Monitor:** Nails from the underlying layers of shingles and or flashings are working their way up through the top layer of shingles in isolated areas. See the photograph below on the left. Ideally the affected shingles should be repaired/replaced. As the exposed fasteners are minimal at this time it may be possible to simply seal the exposed nail heads with a high quality mastic. It will be necessary to periodically check these repairs and reseal them. For additional information we suggest that you consult with a roofing expert.

- **Monitor:** Prior repairs to the roofing are evident. See the photograph above on the right. This would suggest that problems have been experienced in the past. This area should be monitored.

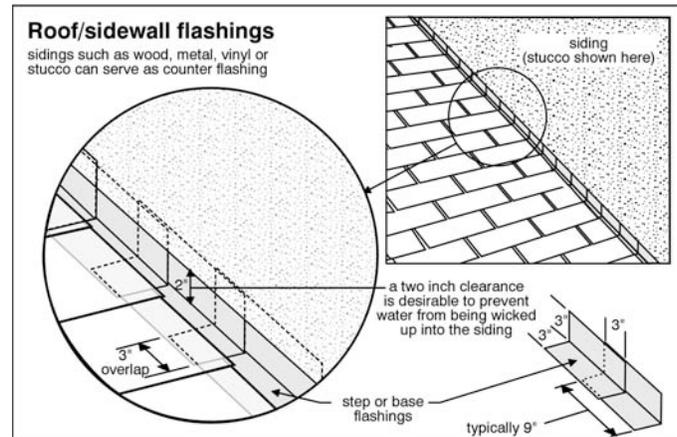
- **Repair:** The clearance of the siding to the roof coverings is insufficient. This condition leaves the siding vulnerable to rot. This detail is usually repaired when siding needs repair or replacement or when re-roofing work is performed. The illustration to the right indicates stucco wall cladding. Manufactures of hardboard or cement fiber siding also require a minimum of 1"-2" of clearance for their products as well. Note the diagram to the right.

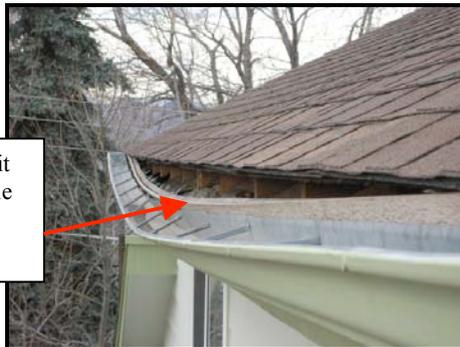
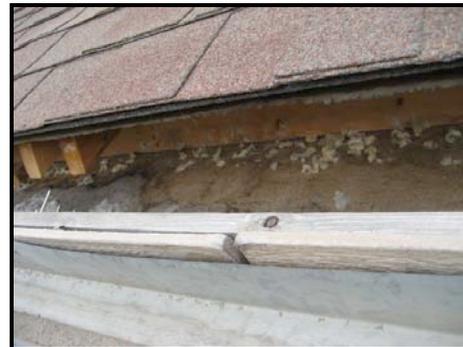
Major Concern: Repair: The soffit and fascia at the south side has pulled from the home. This is very likely the result of last year's severe winter and extreme amount of snow. The damage to this area requires immediate repair. See the two photographs below in the exterior section of the report.

- **Repair:** The loose gutters on the south side of the upper roof should be repaired or replaced as necessary to avoid spilling roof runoff around the building – a potential source of water entry or water damage. See the additional comments and photographs below in the exterior section of the report.

- **Major Concern: Repair:** The soffit and fascia at the upper roof at the south side has pulled from the home. This is very likely the result of last year's severe winter and extreme amount of snow. The damage to this area requires immediate repair. See the two photographs below.

Entire fascia and soffit has pulled loose on the south side of the building

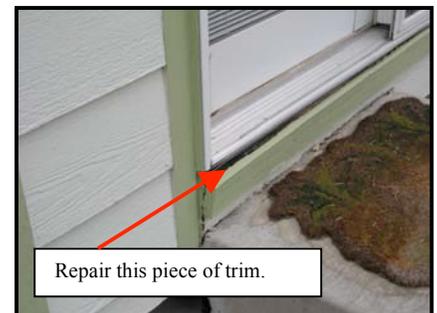
- **Repair:** The damaged trim below the rear patio door should be repaired or replaced as necessary. See the photograph to the right.
- **Monitor: Repair:** There is a vertical crack in the veneer brickwork at the masonry between the two garage doors. The exact cause of the cracking is not determinable based on this limited visual inspection. A possible cause is freeze thaw cycles. This does not appear to be a structural concern and repair other than for aesthetic is optional.

Repair this piece of trim.

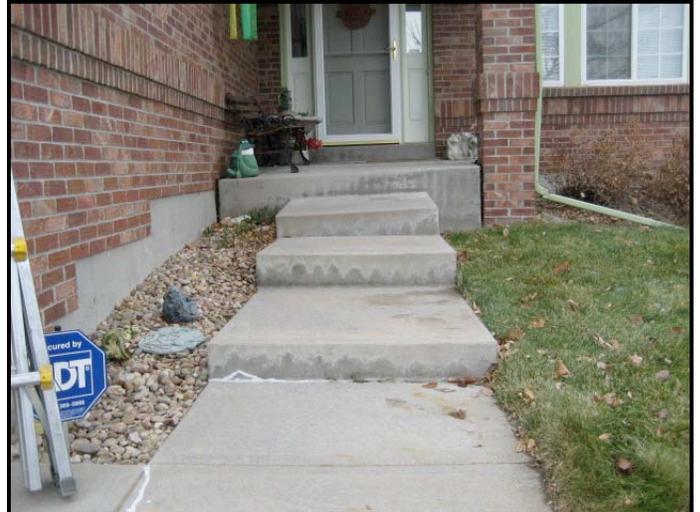
- **Possible Major Concern, Monitor:** The front porch and walk way has settled relative to the house proper. This is a common condition normally attributed to inadequate compaction during original construction. At the time of the inspection a modest trip hazard exist. Ideally the front walk and stop should be removed and repoured if only for aesthetic reasons. Mudjacking of the front walk and stoop could also be considered. Minimally the condition should be monitored and repaired if a significant trip hazard develops.
- **Repair, Safety Issue:** The rear patio is also cracked and has settled and has some potential trip hazards. This condition should also be monitored and repaired if the condition worsens. If the front porch is ever repaired/repoured it would be prudent to replace this patio at the same time.

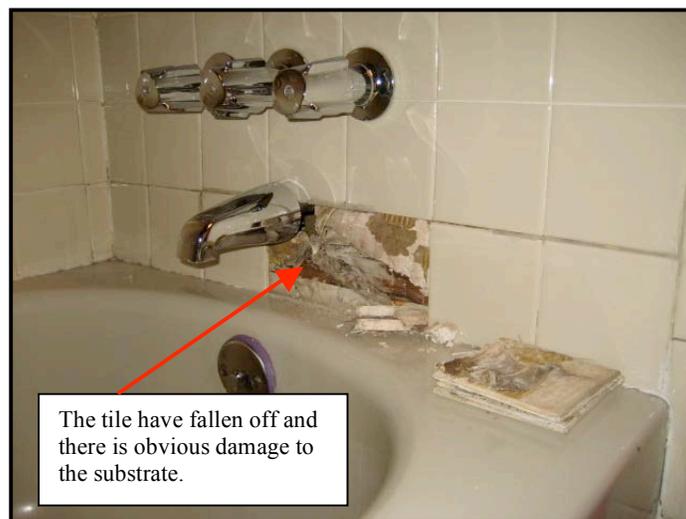
Repair: The tile surround for the second floor hall bathtub is in need of major repair. There are several loose and or missing tiles. The condition of the substrate is damaged based on the limited accessibility and will likely require substantial repairs depending on what conditions exist once the major repairs are in process. We suggest consultation with a contractor to determine the extent and cost of repairs required. See the photographs below in the plumbing section.

- **Repair:** The tile surround for the second floor hall bathtub is in need of major repair. There are several loose and or missing tiles. See the photograph to the right. The condition of the substrate is damaged based on the limited accessibility and will likely require substantial repairs depending on what conditions exist once the major repairs are in process. We suggest consultation with a contractor to determine the extent and cost of repairs required.
- **Monitor:** The majority of plumbing fixtures are at or approaching the age where they may require some routine maintenance and or repairs or eventual replacement. It would be typical to have to replace older washer or faucet cartridges to keep faucets from dripping.

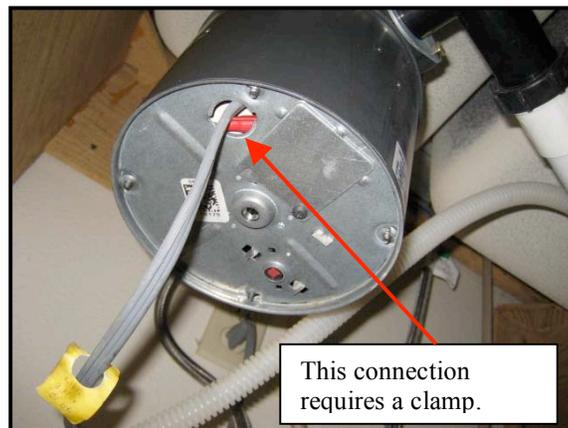
- **Repair: Safety Issue:** The wiring leading to the waste disposer is deficient. The wiring is not properly clamped at the bottom of the disposer exposing the wires to potential abrasion on the housing of the disposer. See the photograph to the right. This is potentially a dangerous condition that could be a shock or potentially an electrocution hazard. The wiring should be repaired as soon as possible.
